**Wesdyne Report WDI-TJ-001-02-NP, Rev 02,
Detection of Reactor Head Base Metal Loss from Inside the CRDM
(Non-Proprietary)**

Title: Detection of Reactor Head Base Metal Loss from Inside the CRDM Penetration		
Key Words: Technical Justification	Date: 8/14/03	Document Number: WDI-TJ-001-02-NP Rev.2

Detection of Reactor Head Base Metal Loss from Inside the CRDM Penetration

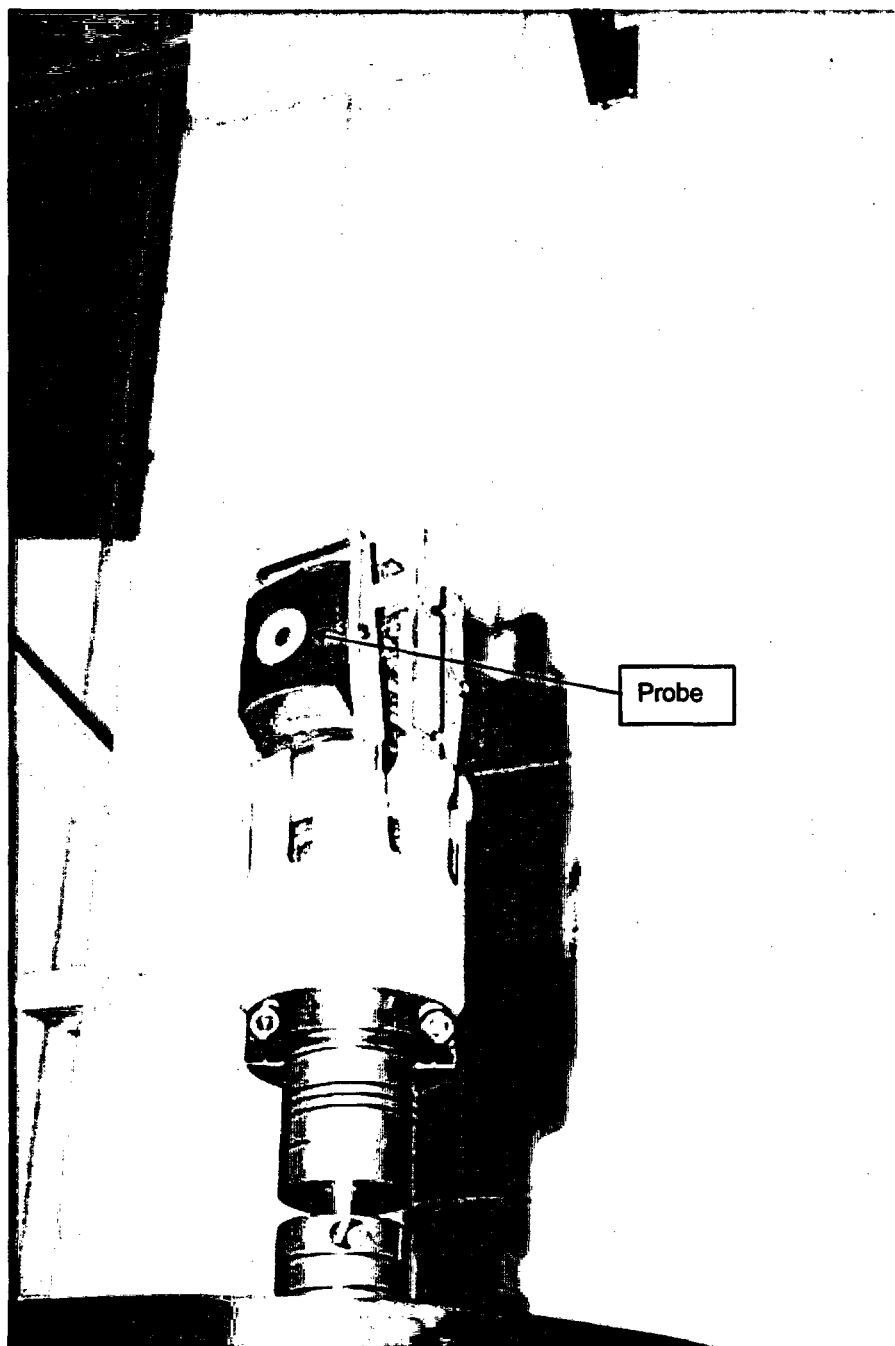
Figure 1 Eddy current probe mounted in the sled of a 7010 manipulator.

To perform the inspection, the eddy current probe is mounted into a tool that scans the probe on the ID surface of the penetration over an extent coincident with the head base metal. Figure 1 shows the probe mounted in a sled on the scanning tool. As the probe is scanned over the area of interest a loss in the base metal is detected as a change in the response of the coil.

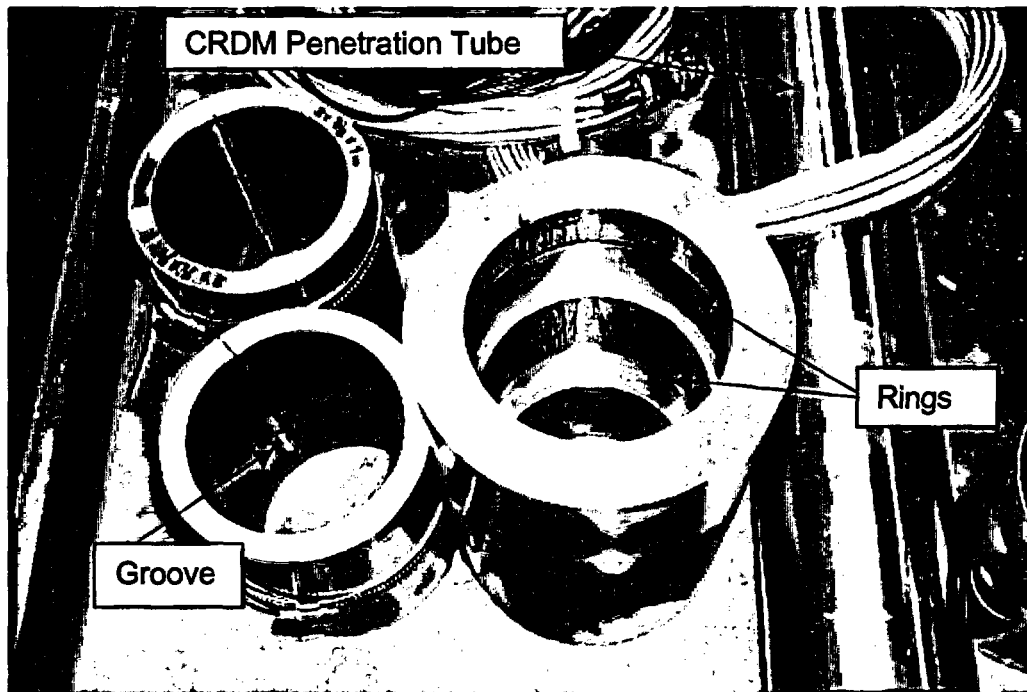
Figure 2 Machined samples used in this evaluation. The samples SK-WB08-1 through - 4 are shown clamped together. The penetration tube was used in the test stand.

Figure 2 shows the samples that were machined for this evaluation. They include two material loss morphologies. The first is uniform loss that is simulated by rings cut into the inside of a hollow cylinder. The second is localized loss that is simulated by axially oriented grooves cut into the inside of a half-cylindrical section. Table 1 lists the nominal dimensions for all of these samples. The samples in Table 1 were machined to fit the CRDM penetration tube R 6517-2 with an outside diameter of 4.10 inches and a wall thickness of 0.685 inch.

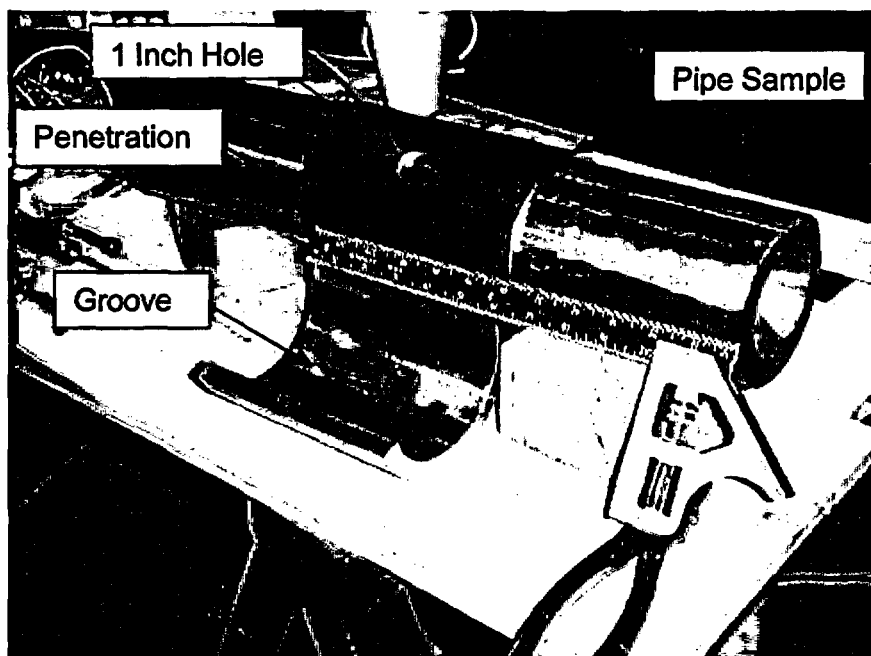
Figure 3 The tube sample with the through wall holes mounted on the penetration tube. In front is the groove Sample SK-WB08-04.

As a further check on inspection sensitivity an additional sample was fabricated from a section of pipe that was bored to fit over a penetration of 4.150 inch diameter. The resulting tube had an approximately $\frac{1}{4}$ inch thick wall into which two through holes of { } were drilled (Figure 3).

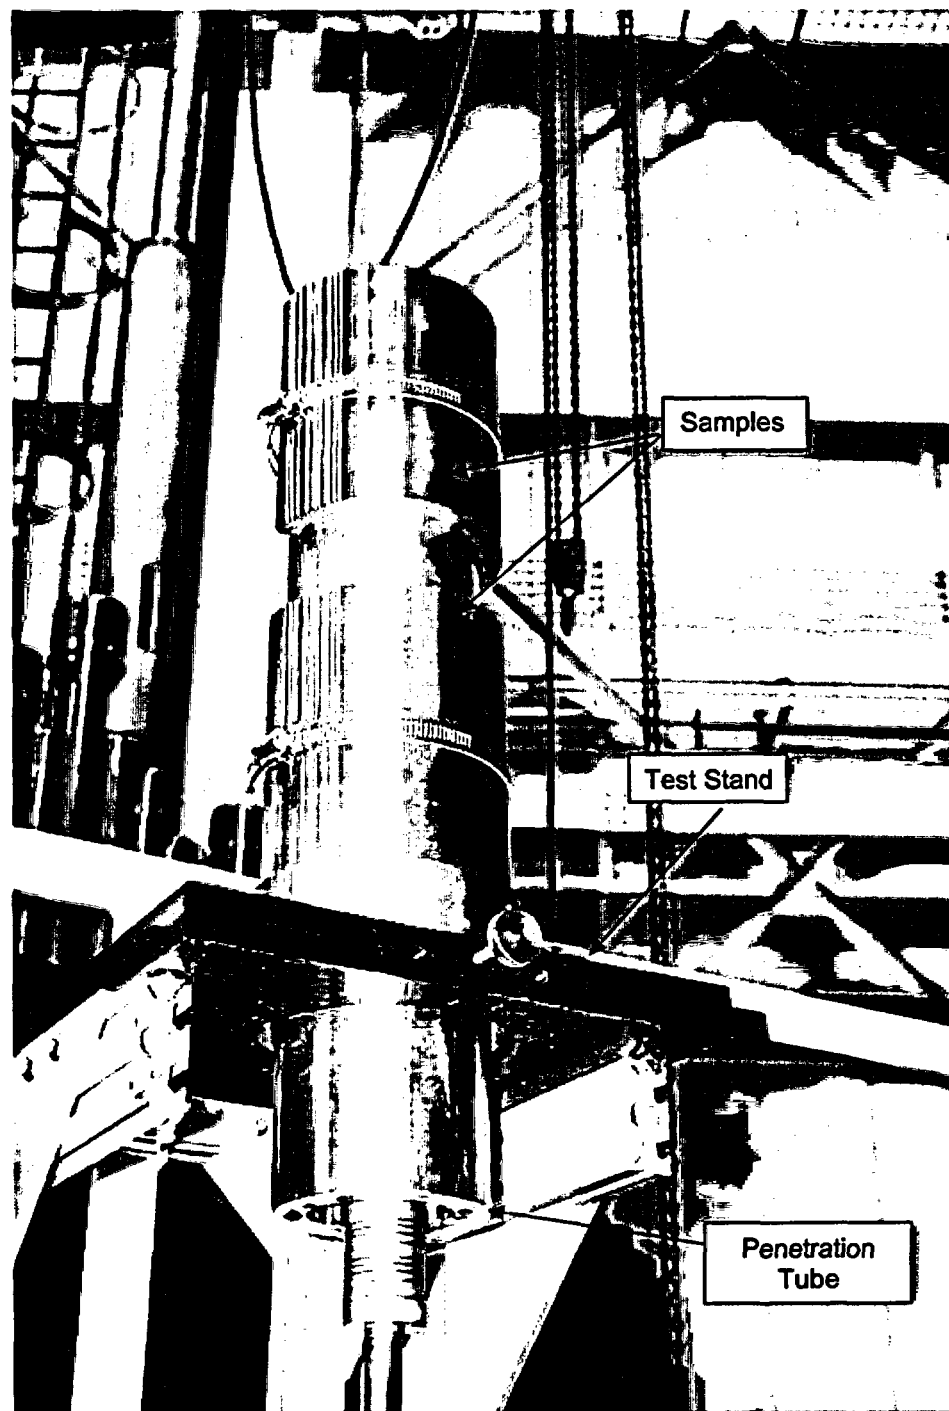
Figure 4 Half Cylinder Samples mounted on test stand. The samples are shown mounted for the “Gap” dependence study and are at the 2.0-inch separation.

Tests using the machined samples were performed either on a test stand or with the samples surrounding a penetration tube on the head. Figure 4 shows two of the half cylinder samples mounted in the test stand. Figure 5 shows the ring sample (SK-WB020408-3) mounted on a penetration on the head.

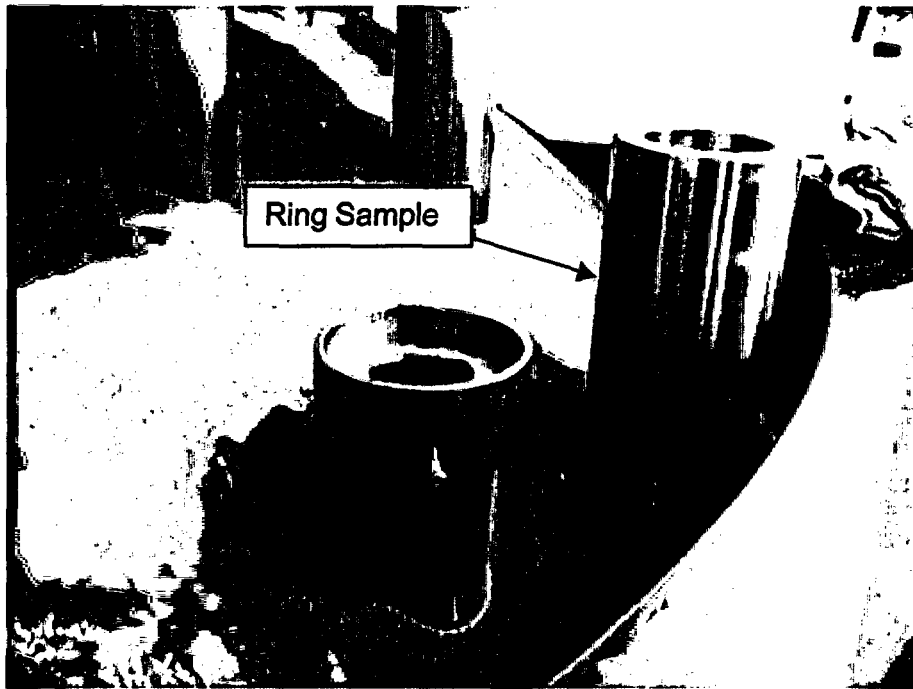
Figure 5 James Port Head with calibration ring and ring sample in position.

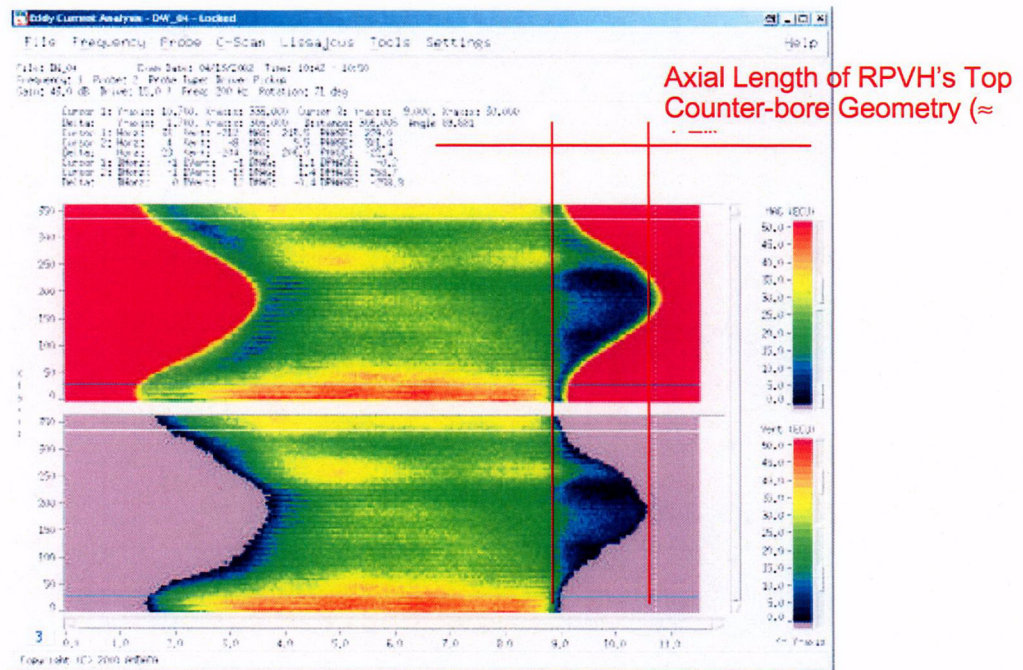
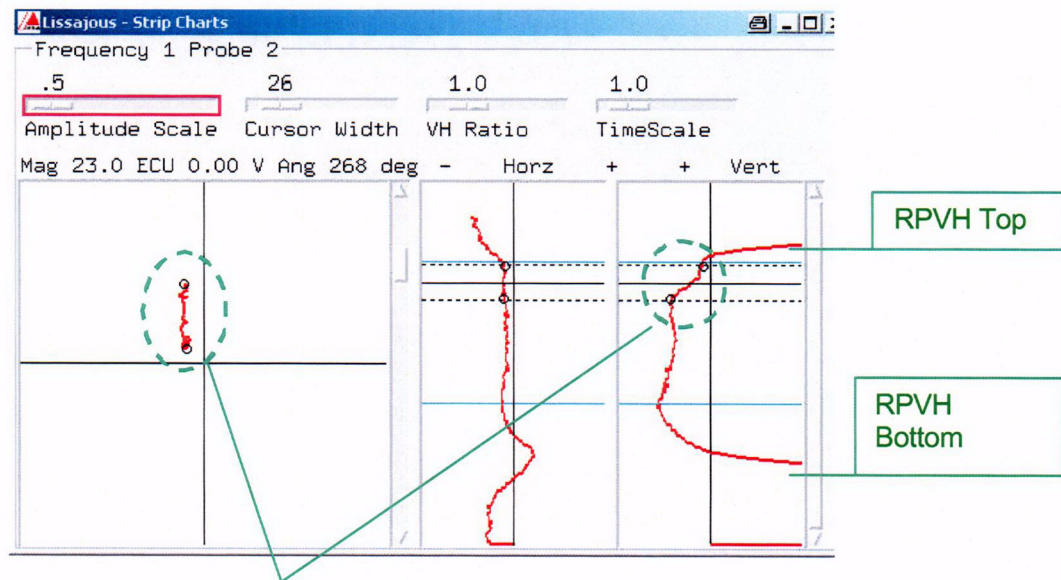
Eddy current responses from inspection of CRDM Penetration 26 in the James Port head. The arrows identify the counter bore region in both the C-Scan and strip chart displays.

Inspections were performed on six penetrations in the James Port reactor head. This head is from a cancelled plant. All of the displays for these inspections can be found in Appendix A. In general the variations seen in the head inspection are smaller than the variations observed in the machined samples. This fact allows for the counter bore at the top of the head to be observed. The counter bore is a radial opening of the hole in the head through which the penetration is inserted. The counter bore extends over the portion of the hole that is on the "high" side down to the "low" side. Figure 10 shows the results from Penetration 26 with the counter bore obvious in the display.

In reviewing the results the variations in response observed in the machined samples figure 9 is significantly (two times) higher than that observed in the head Figure 10. The origin of the variation has not been definitively identified but is believed to originate with a combination of material variability with in the penetration tube being used in the test stand and residual magnetic fields within the samples. These variations limit the detection of low level loss. Without these variations the signal to noise should improve allowing the detection level in the head to also improve over that observed in the samples.
